TRACTION TEST ON « BUZON » DPH5 PEDESTALS

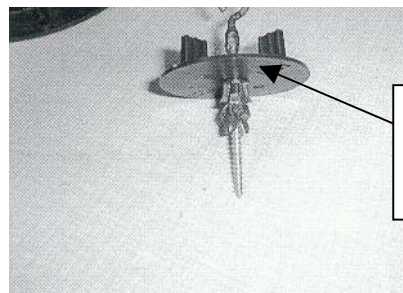
pegs of the tray with tabs
